# Handover Inspection Report

4-Bedroom Townhouse, Dubai · Sample Report

Inspection Date: 24 May 2026    Inspector: Mustafa Al Omari (Inspecto)

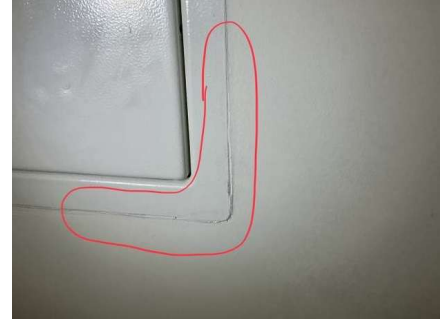
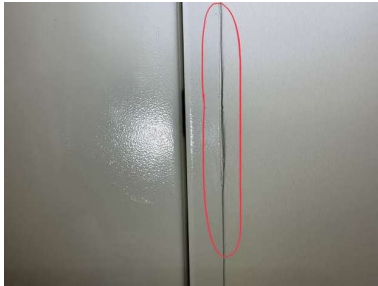
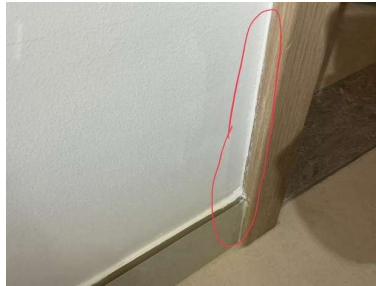
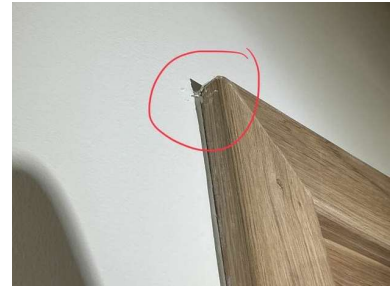
#219 - Inconsistent finishing around electric panel and bathroom door frame.

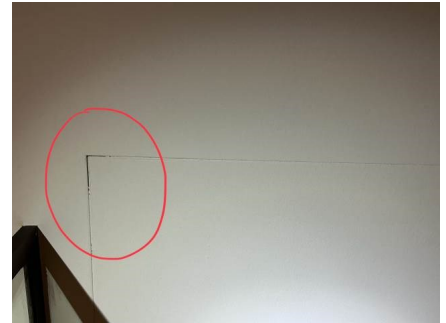
## #221 - Ceiling panel in bathroom is misaligned- has uneven gap

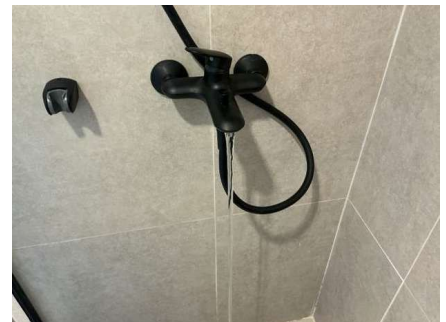
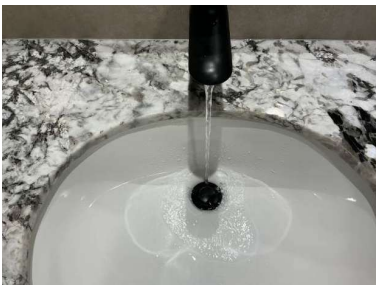
## #222 - Water pressure is noticeably low in all water supplied throughout the entire unit

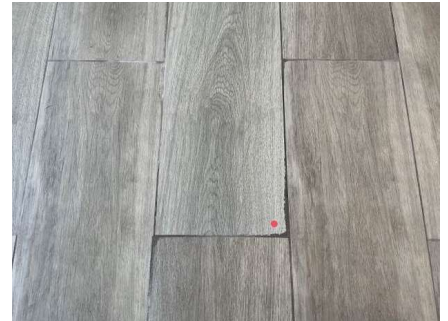
#197 - Inconsistent finishing of wood flooring, excess material to be cleaned and rectified including light switches

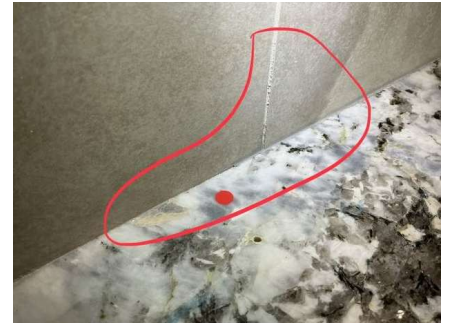
## #199 - Minor inconsistencies seen in finishing

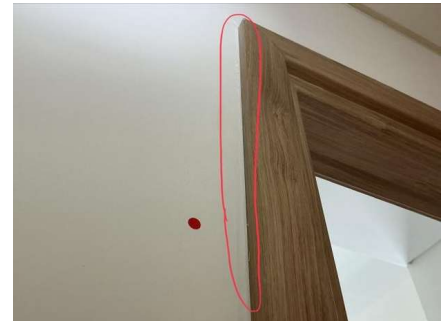
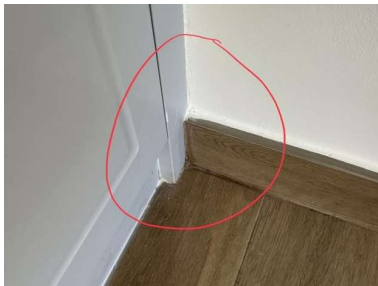
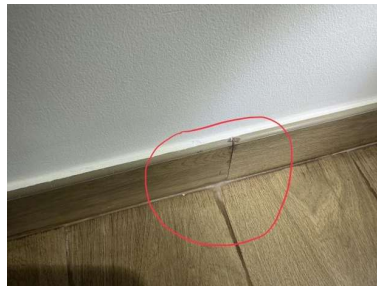
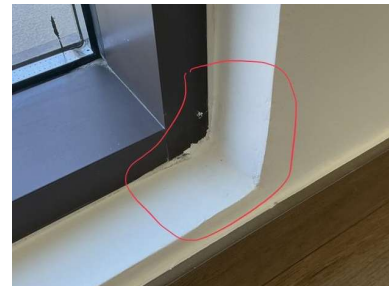
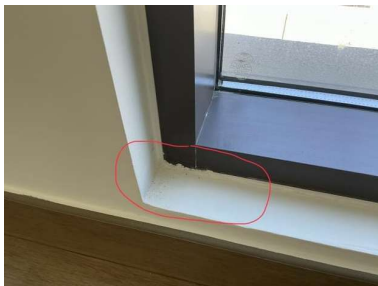
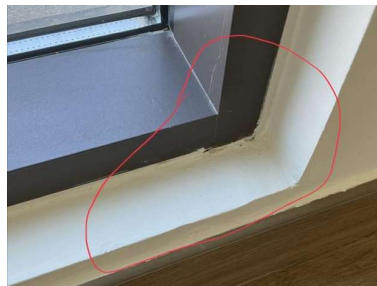
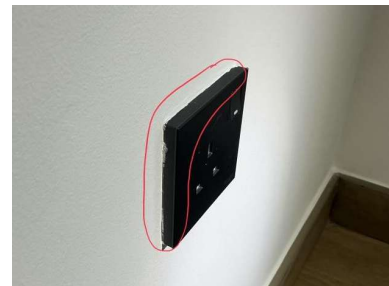
#209 - Poor finishing and inconsistent texture seen on/around the bedroom door frame, window frame, power socket and skirting

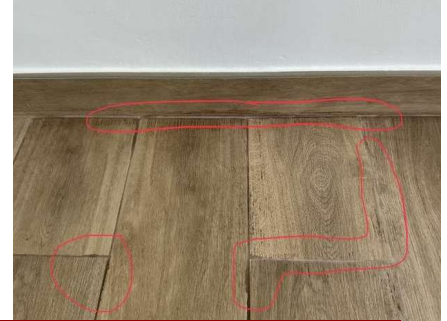
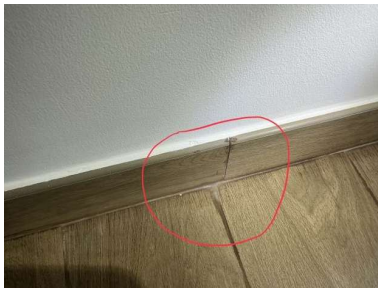
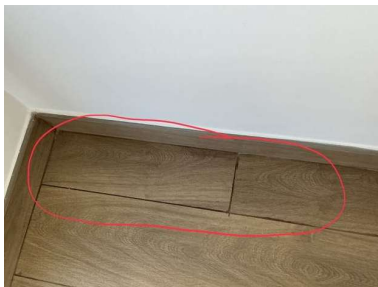
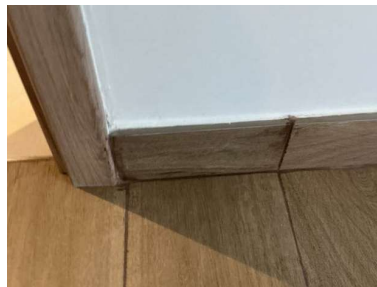
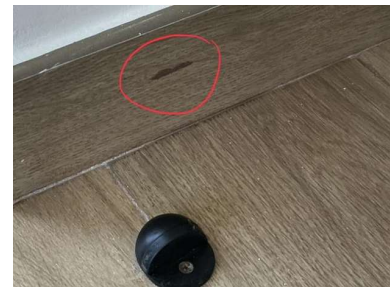
#211 - Visible color variation seen on wooden flooring, present in multiple areas such as the hallway and bedrooms

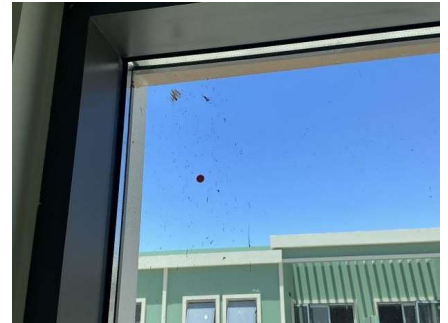
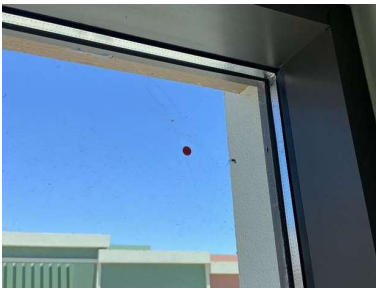
## #212 - Window and window frame to be cleaned thoroughly, must be free of marks and stains

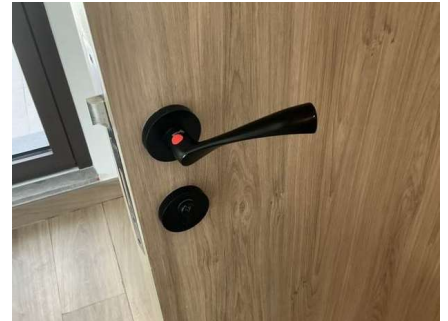
## #214 - Handle slightly loose

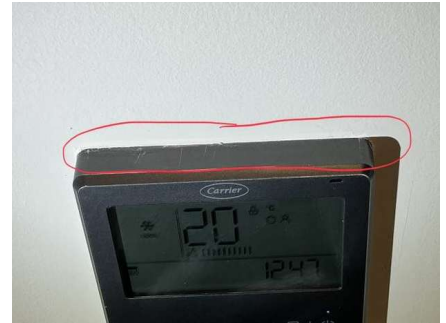
## #215 - excess paint residue seen on/around the AC panel in the hallway

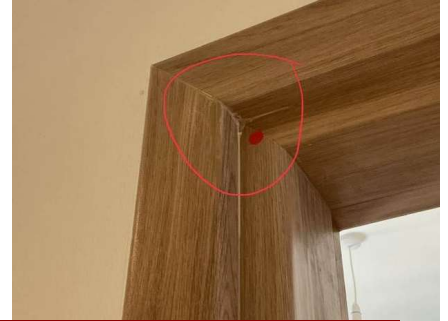
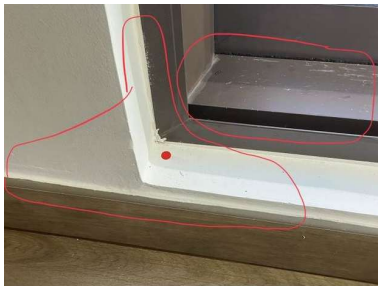
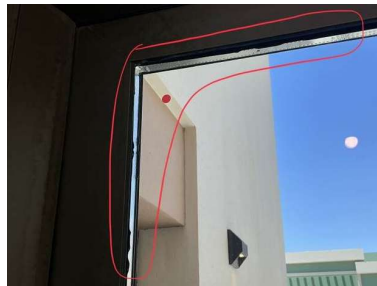
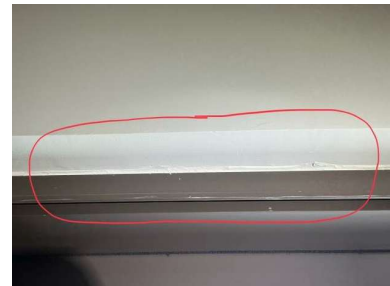
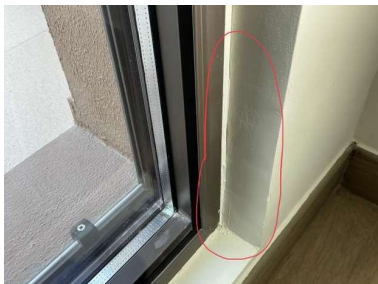
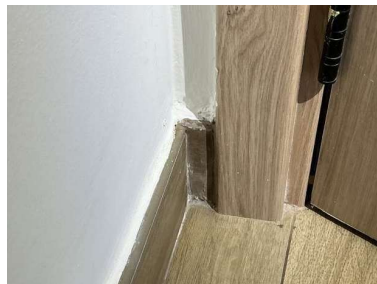
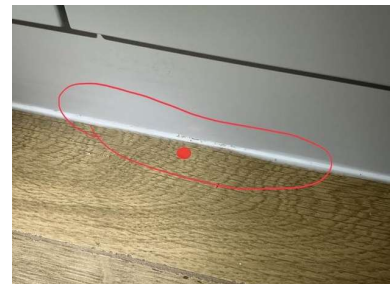
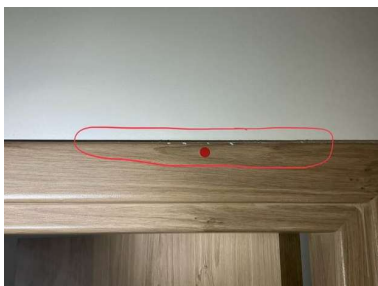
#217 - Inconsistent finishing between wall and door/window. Minor gap seen in door frame and in sealer. All windows, doors and wall to be cleaned and rectified

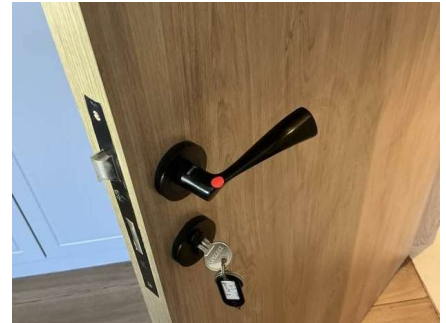
## #218 - Door handle is slightly loose

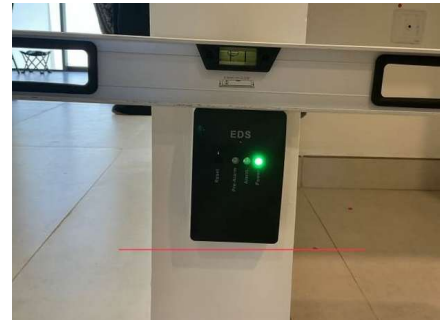
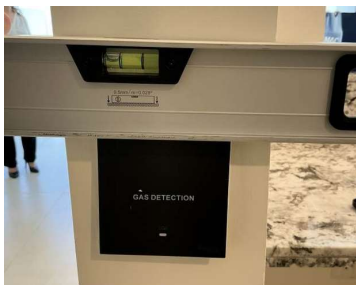
#201 - Gas detector is slightly misaligned

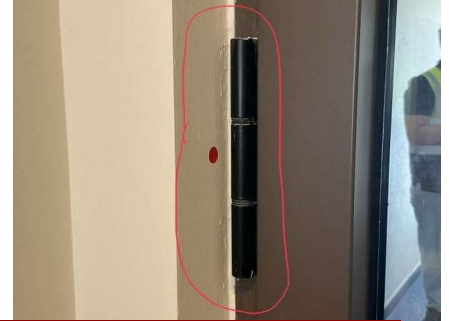
#203 - Inconsistent wall texture seen near window hinge. Excess paint seen on lightswitch and sealant seems to be inconsistent

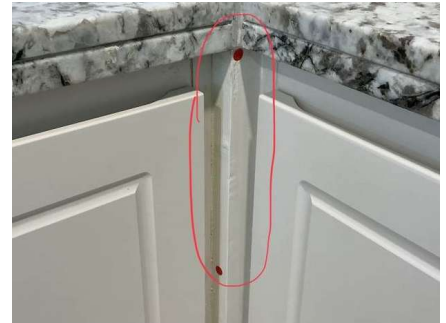
## #204 - Poor finishing around the kitchen cabinets

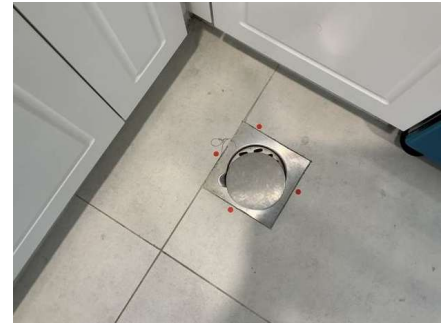
### #240 - Uneven gap and visible color variation of the kitchen drain

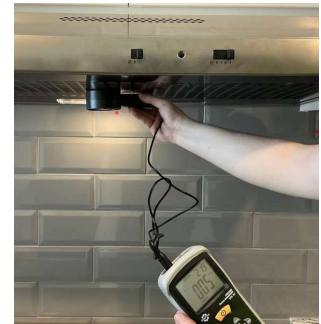
### #241 - Cooker Hood/ Extractor fan is very weak

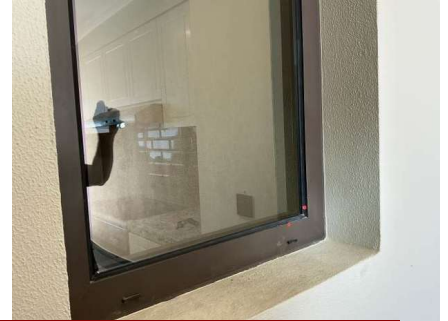
#192 - Exterior window in entrance, has visual inconsistencies seen in the sealant - window frame to be cleaned and free of scuffs

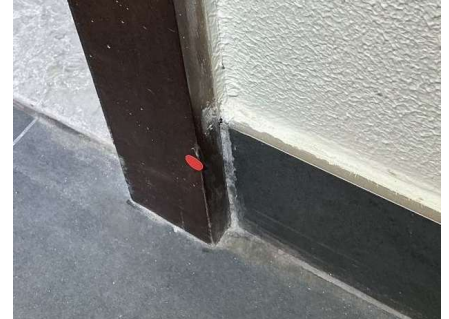
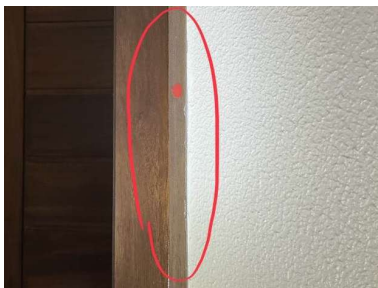
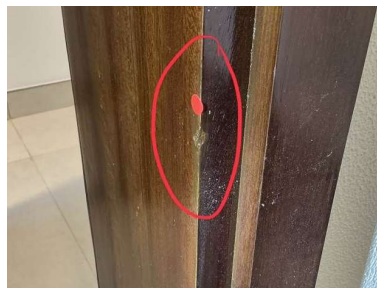
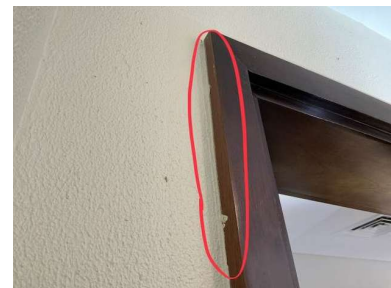
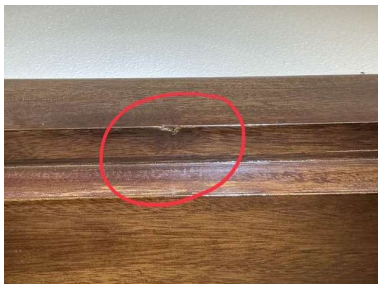
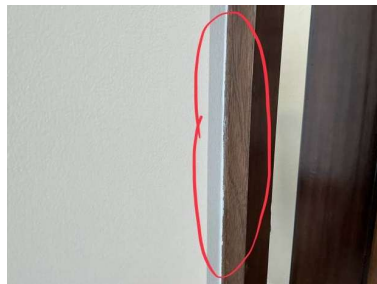
#193 - Minor scuffs and chips seen on the main entrance door and frame, to be cleaned and free from any marks/scuffs, visible scratches seen

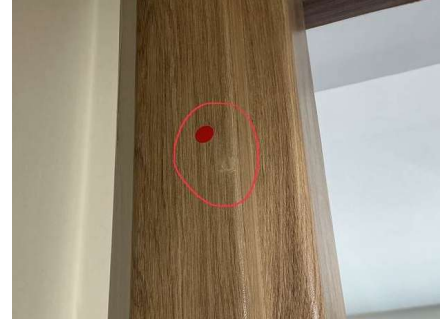
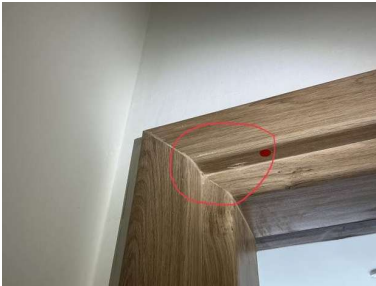
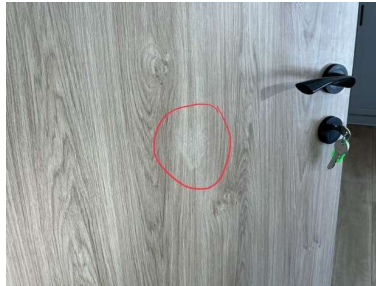
#223 - Minor scuffs on master bedroom door and frame

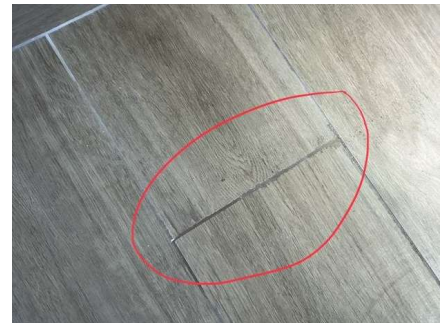
#225 - Color variation seen in wooden flooring throughout the unit

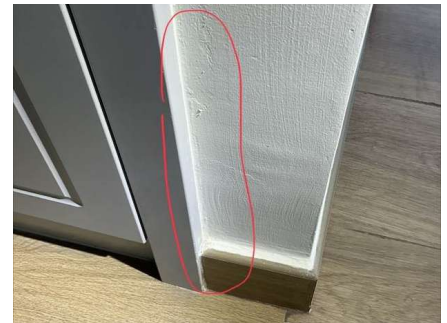
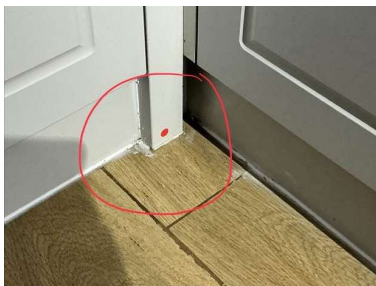
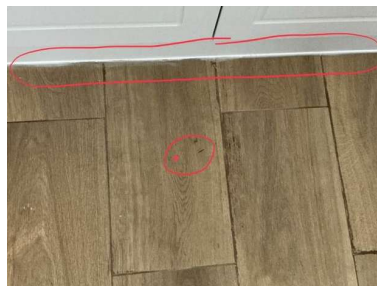
### #227 - Inconsistent finishing

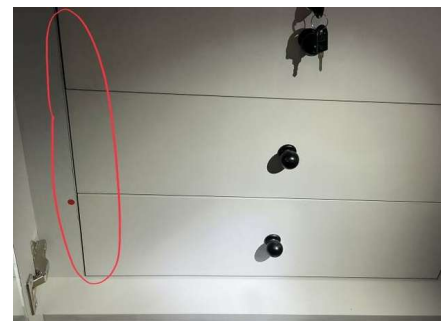
### #228 - Minor scuff seen on left side of wardrobe. Also minor damage seen inside the wardrobe drawer

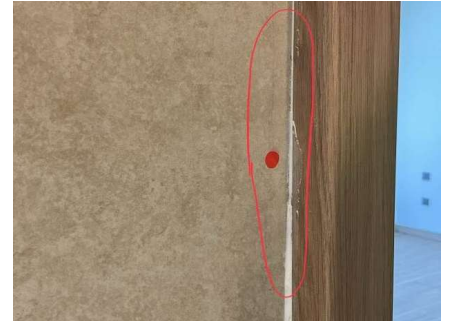
#229 - Inconsistent finishing seen near the master bathroom door frame, shower fittings and between the wall and wall tiles

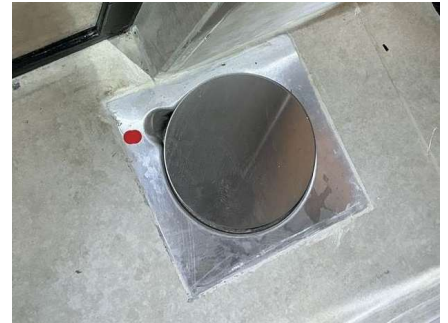
#230 - Minor scuffs/marks seen throughout the bathroom, primarily on wall tiles and near the drain

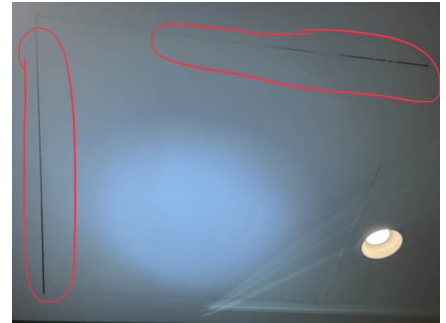
### #231 - Ceiling panel has uneven gaps
