# Handover Inspection Report

4-Bedroom Townhouse, Dubai · Sample Report

Inspection Date: 24 May 2026    Inspector: Mustafa Al Omari (Inspecto)

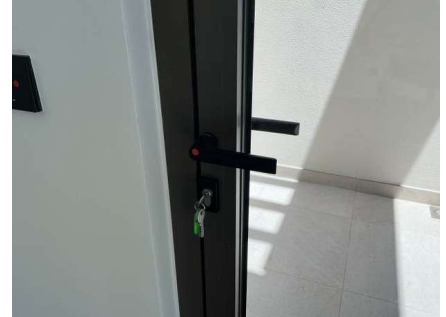
### #233 - Balcony Door makes a squeaking sound when opening/closing

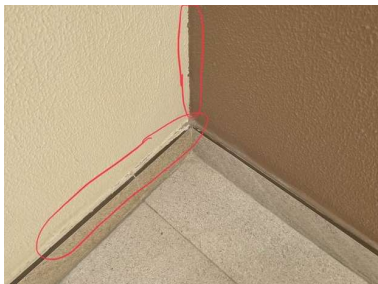
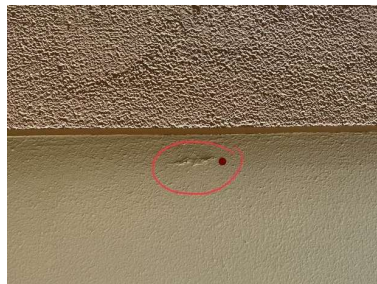
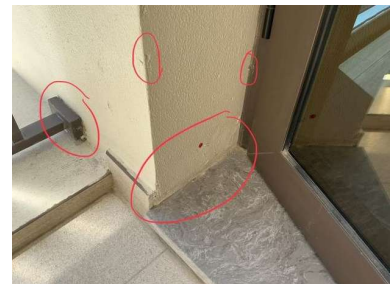
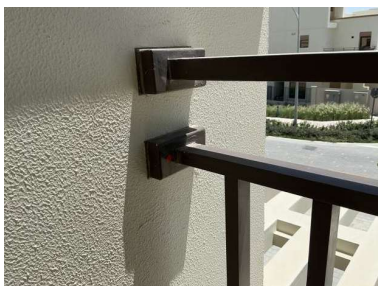
### #234 - Inconsistent paint texture seen throughout the balcony of the master bedroom. Hand rails to be cleaned and free of any marks and scuffs

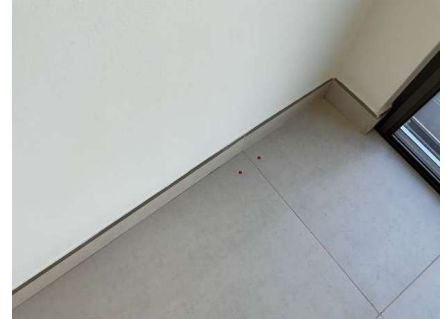
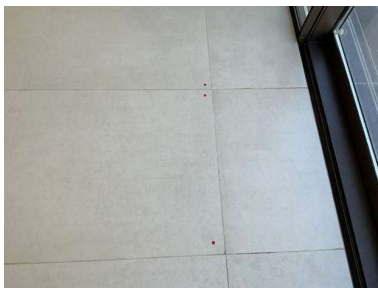
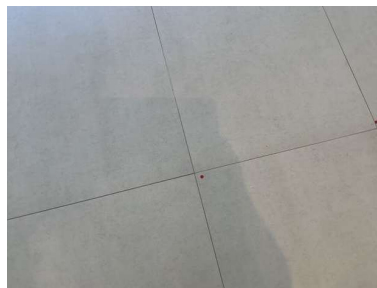
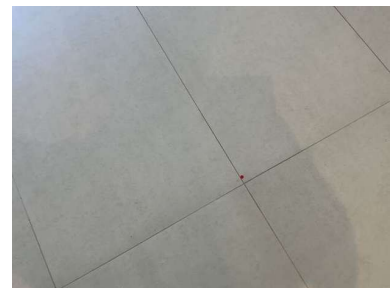
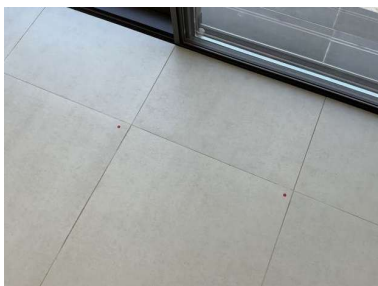
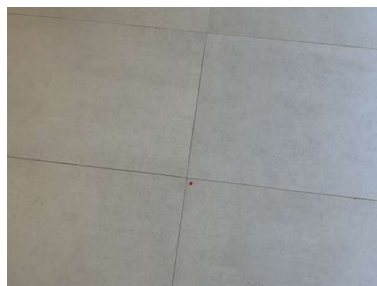
multiple tiles have hollow sound- marked with a red sticker

Hollow sound / cavity in fixing

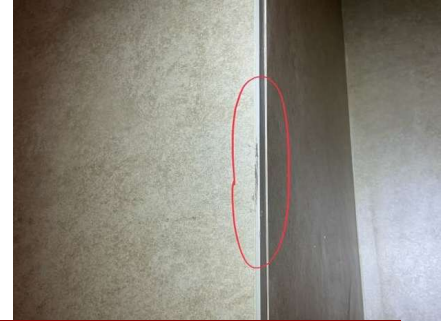
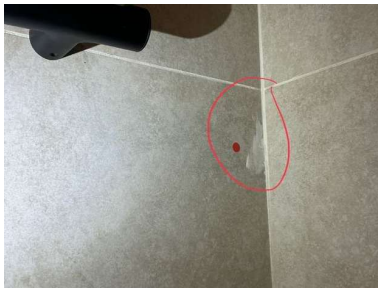
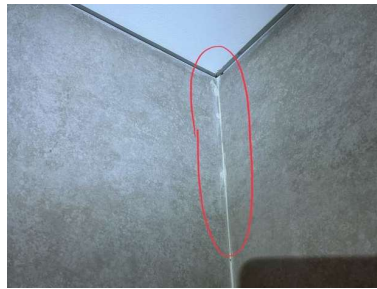
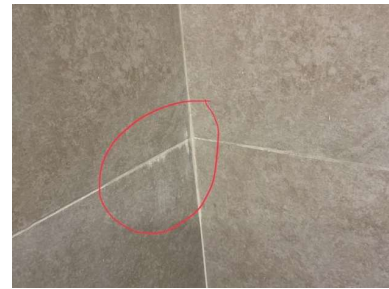
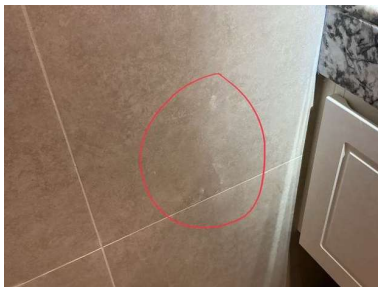
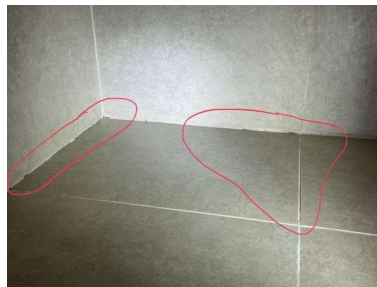
#220 - Minor scuffs and marks present throughout the bathroom, minor gaps/cracks seen inside sealer between multiple tiles (shown in above photos). Door hinge and other fittings to be cleaned thoroughly

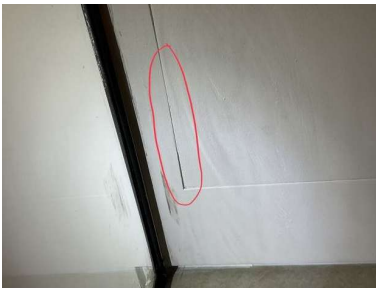
## #221 - Ceiling panel in bathroom is misaligned- has uneven gap

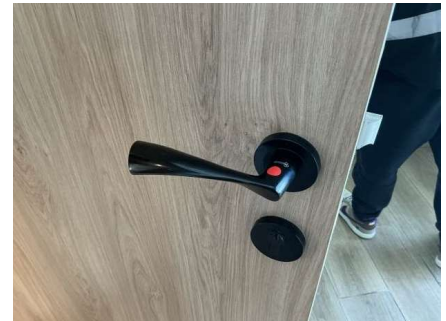
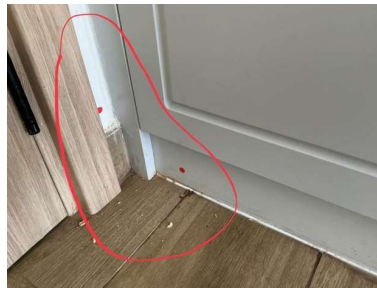
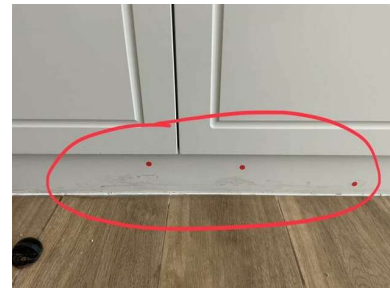
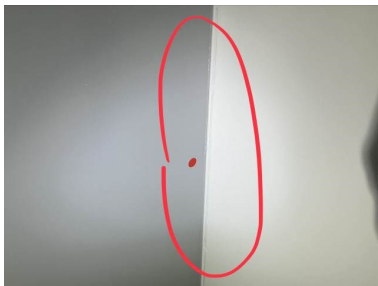
#196 - Bedroom door handles slightly loose, marks and scuffs seen on/around the wardrobe. Finishing between wardrobe and wall is poor, needs to be rectified

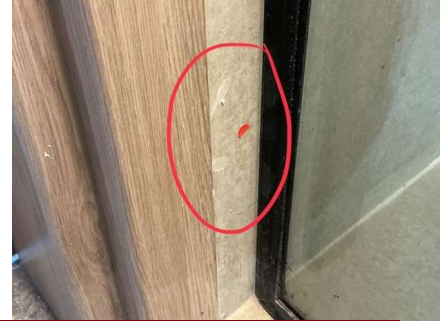
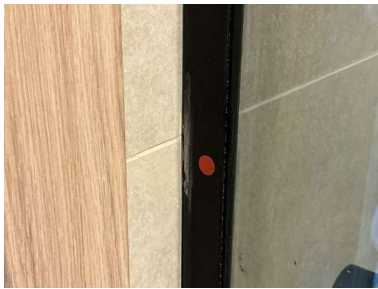
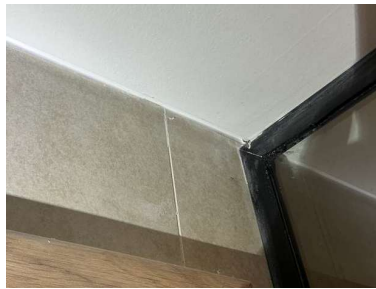
## #199 - Minor inconsistencies seen in finishing

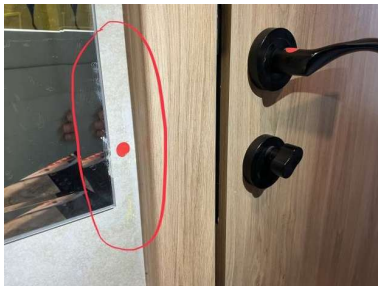
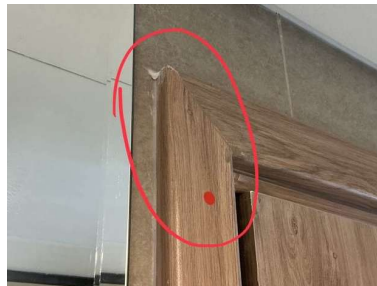
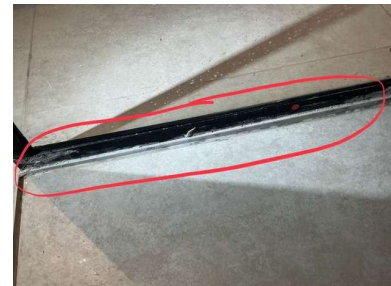
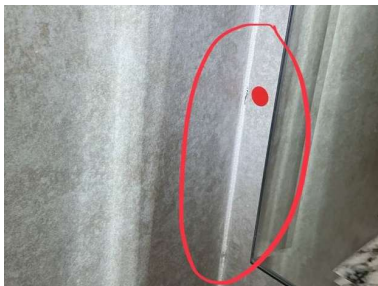
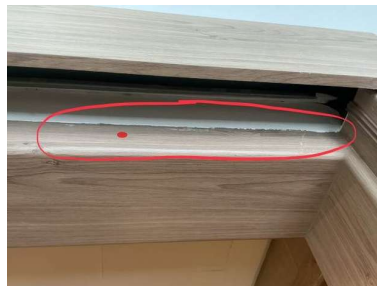
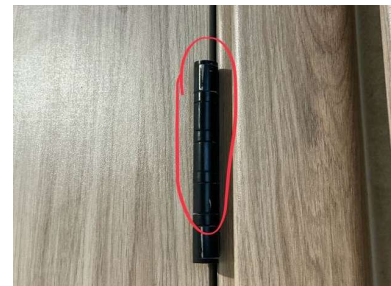
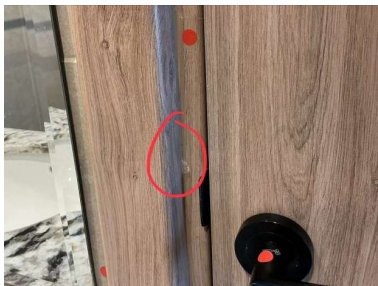
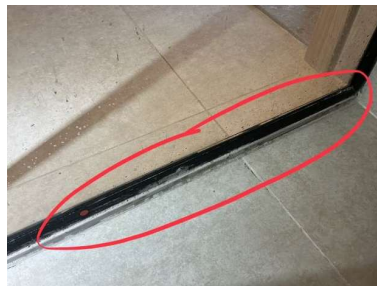
#209 - Poor finishing and inconsistent texture seen on/around the bedroom door frame, window frame, power socket and skirting

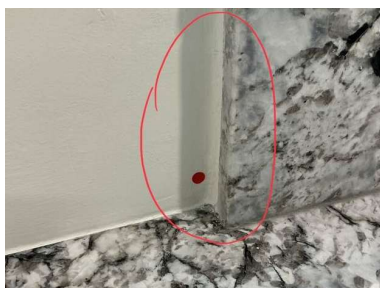
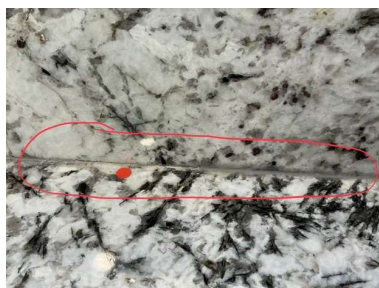
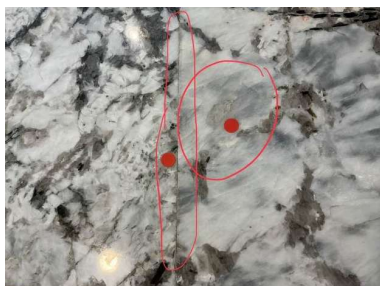
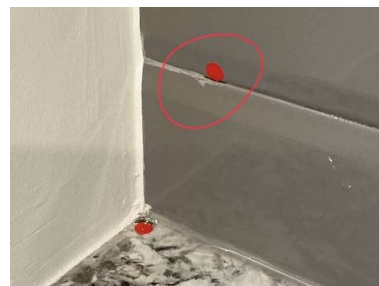
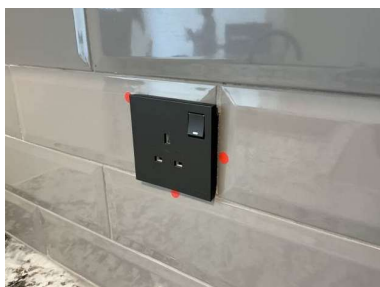
#202 - Inconsistent finishing in multiple areas in kitchen, primarily seen on/around the tiling. Minor gaps seen between tiles and presence of minor scuffs/marks throughout the kitchen. Also minor stains seen inside the kitchen cabinet - to be rectified and cleaned thoroughly

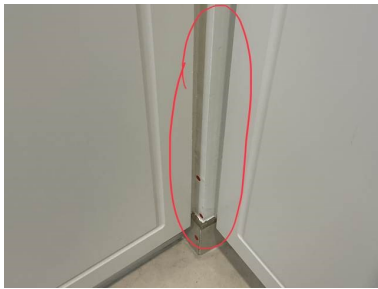
## #204 - Poor finishing around the kitchen cabinets

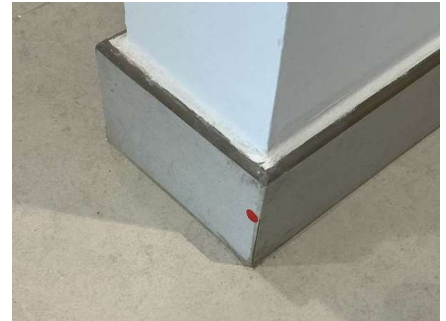
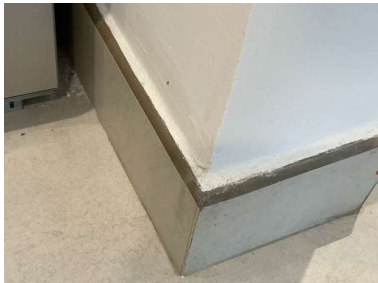
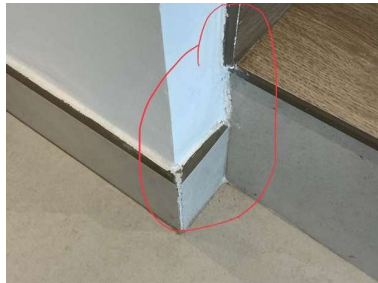
## #205 - Poor finishing seen between the wall and skirting

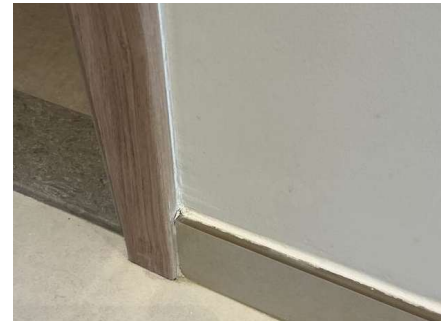
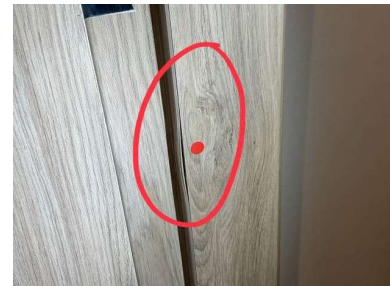
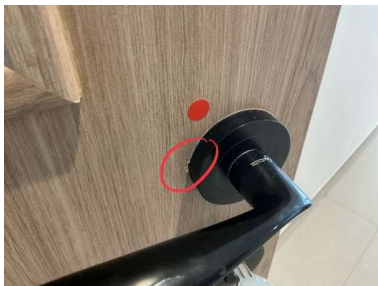
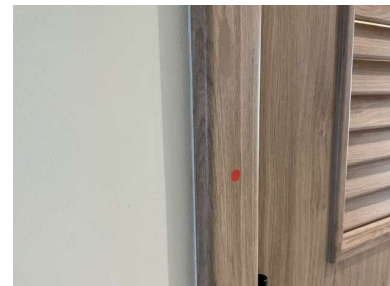
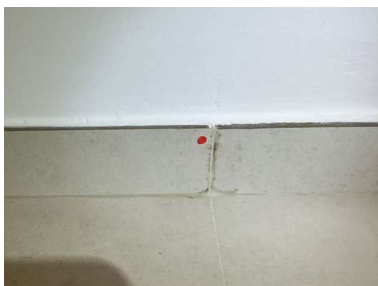
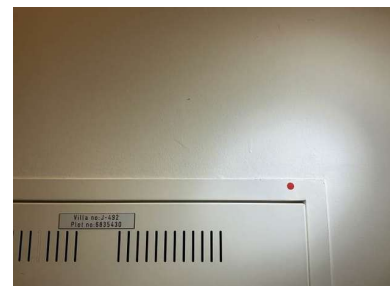
#200 - Poor finishing seen on/around door and frame, walls and electric panel and drain, door handle is also slightly loose

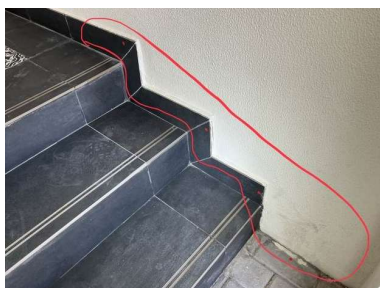
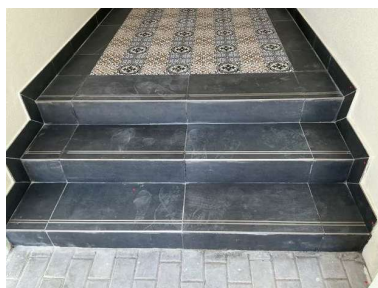
#190 - Sealant between tiles in entrance way not consistent, excess material seen on multiple tiles- to be rectified and clean from any scuffs, marks present

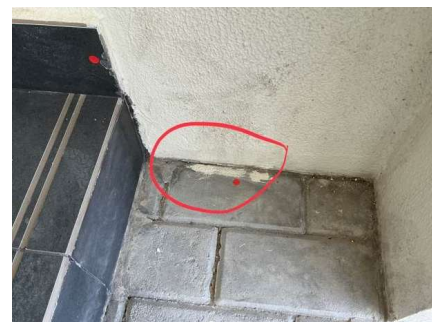
#191 - Excess paint residue seen - to be cleaned

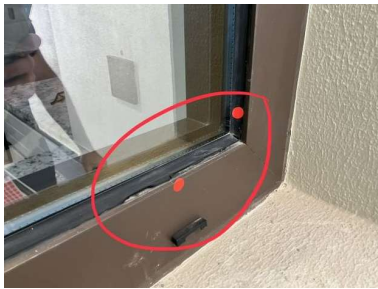
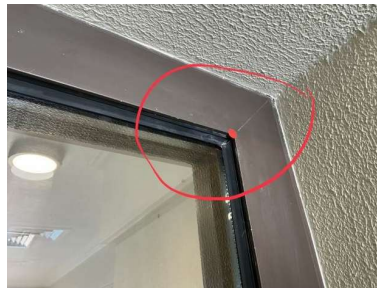
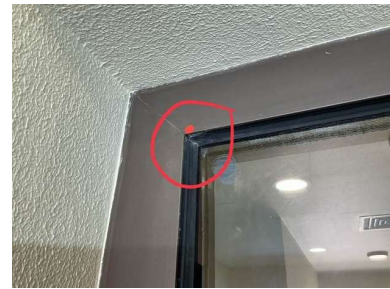
#192 - Exterior window in entrance, has visual inconsistencies seen in the sealant - window frame to be cleaned and free of scuffs

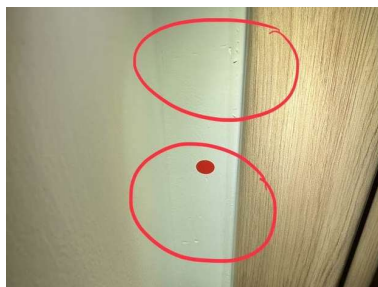
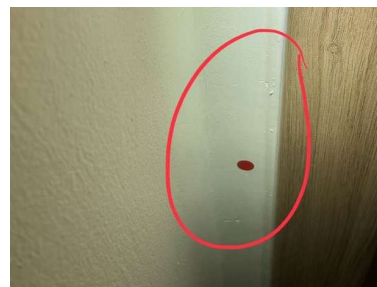
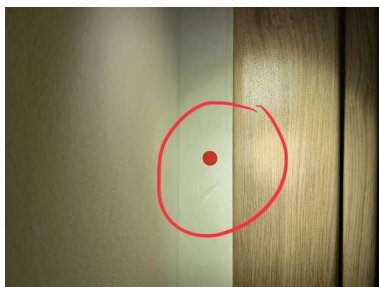
#223 - Minor scuffs on master bedroom door and frame

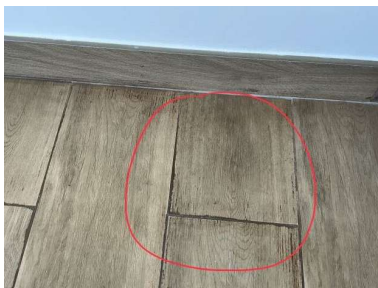
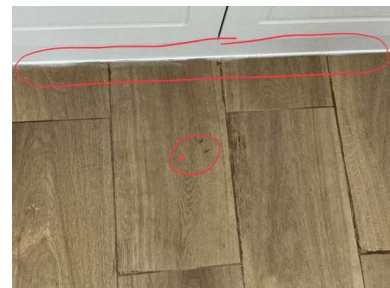
#226 - Wall edge between window and flooring is not straight, visual gap and warping seen. Window and window frame to be cleaned from any marks or excess paint residue

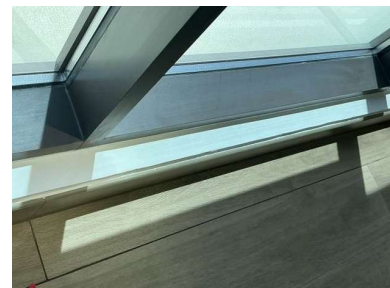
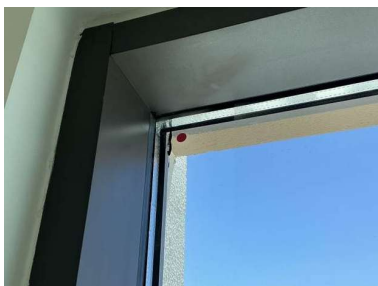
### #227 - Inconsistent finishing

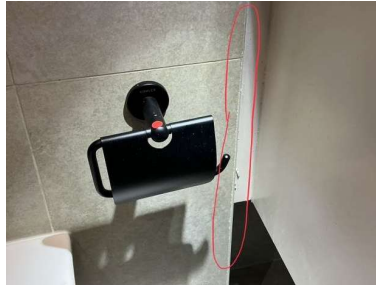
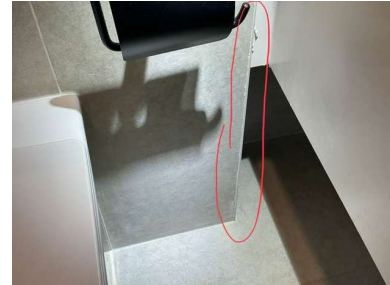
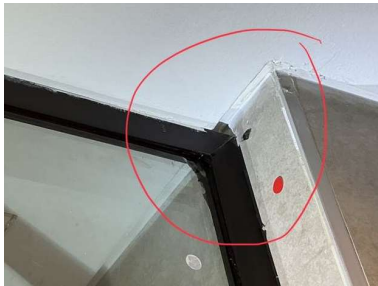
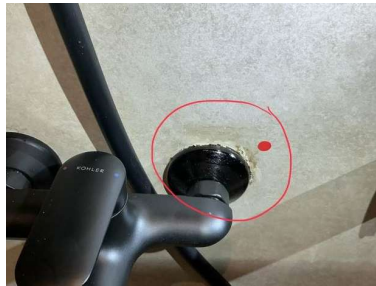
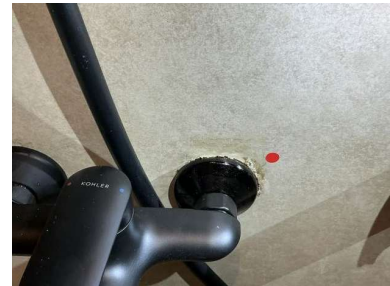
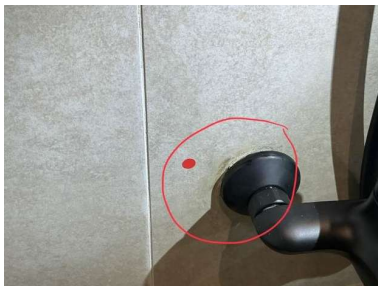
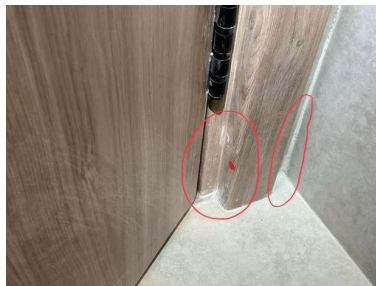
#230 - Minor scuffs/marks seen throughout the bathroom, primarily on wall tiles and near the drain

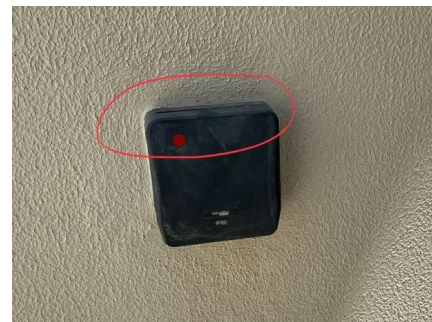
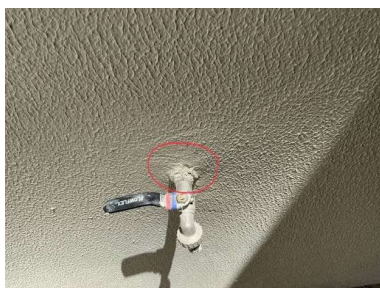
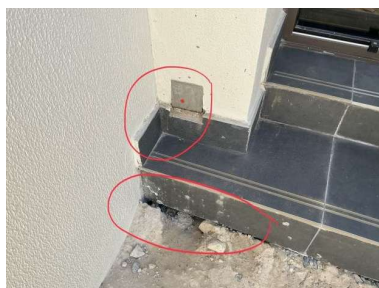
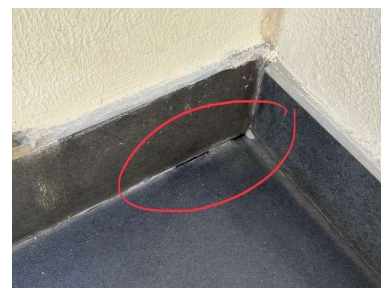
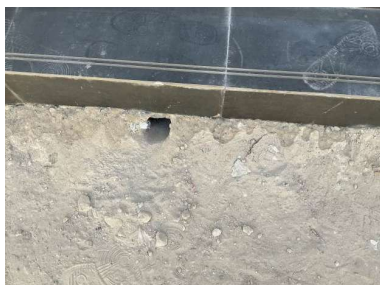
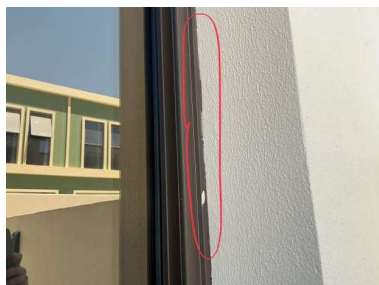
#235 - Minor gap seen between tiles.

Inconsistent finishing around exterior water supply, power socket and door frame

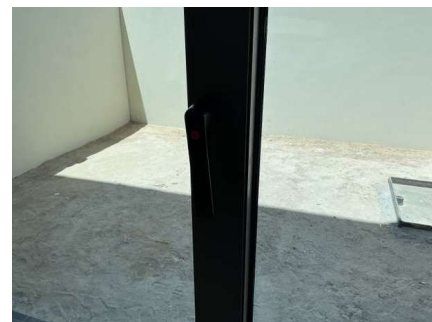
#237 - Sliding Door handle is slightly loose, partially affecting door closure

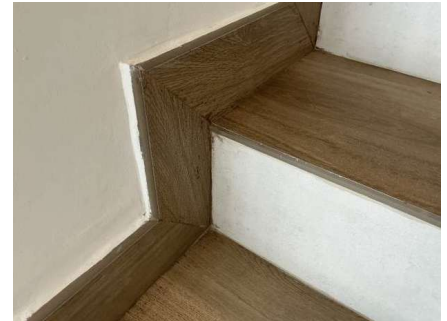
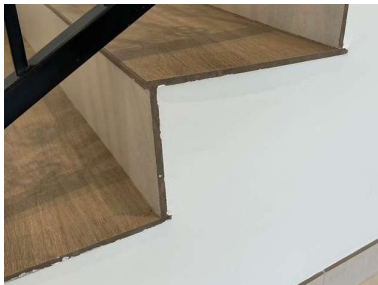
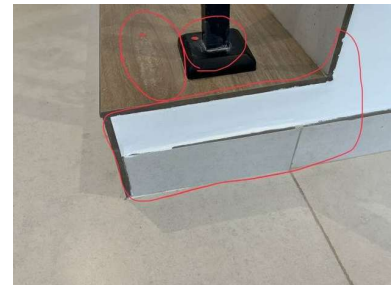
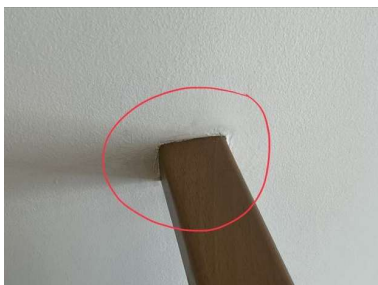
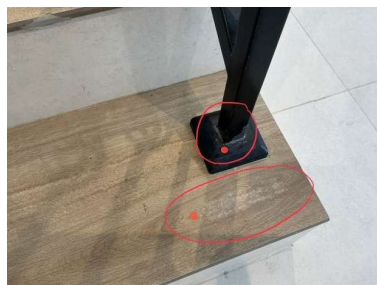
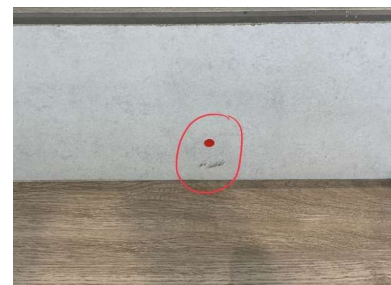
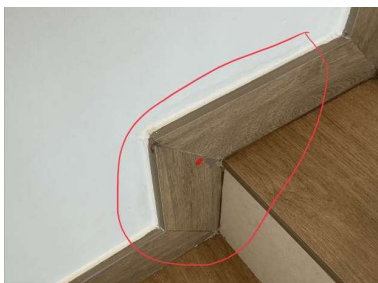
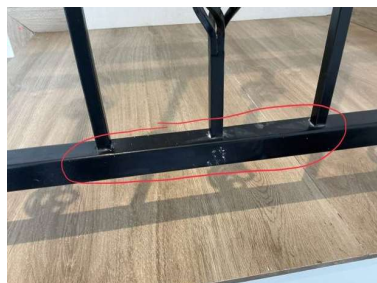
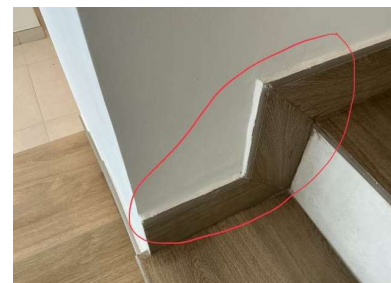
#208 - Inconsistency in finish seen around the staircase fittings, poor texture and presence of minor irregularities such as excess paint, minor scuffs/marks also present - to be rectified and cleaned thoroughly

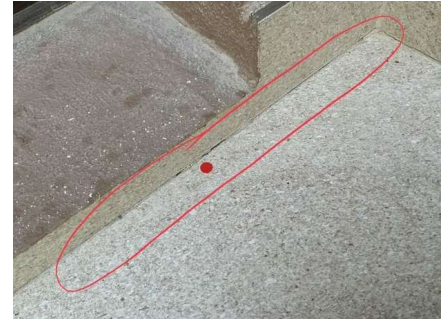
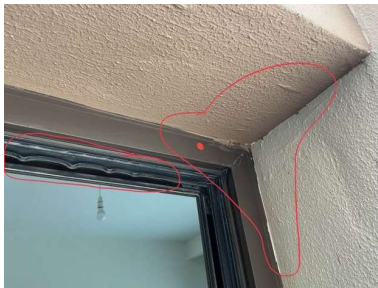
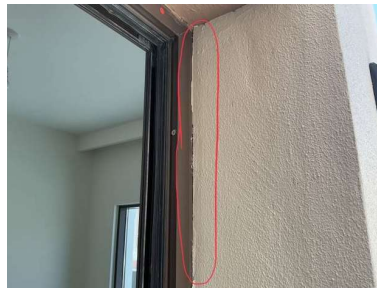
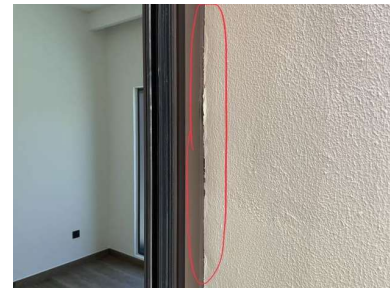
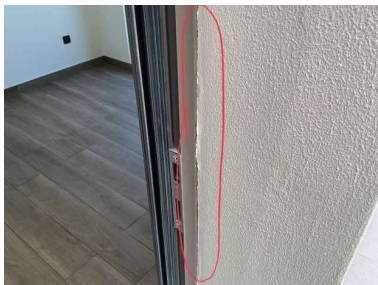
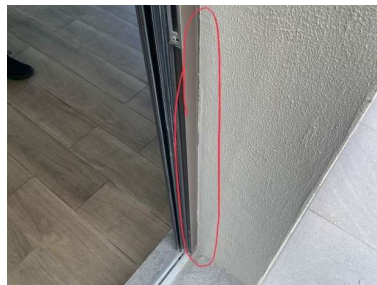
#213 - Minor gap seen in the balcony, and poor finishing seen between the door and wall

Clean and correct defects in wall covering
